**Flood Control Project Maintenance
Levee Inspections**
LMA District Cover Sheet
Spring 2019 Levee Inspection Results

Reclamation District No. 2101 Blewett

Spring 2019 Levee Inspection Results

Levee Inspection Report By Mile - Spring 2019

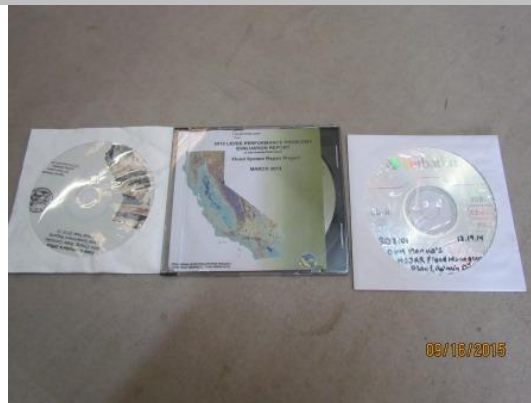
Photo 1 of 1 : SP_2019_RD2101_326_2_20190313_00001.jpg

View of the O&M manual and other documentation.

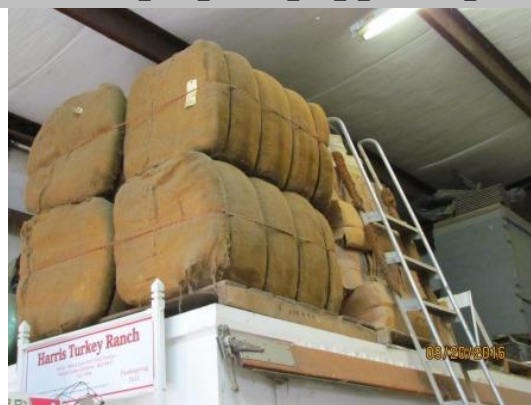
Photo 1 of 2 : SP_2019_RD2101_326_4_20190313_00002.jpg

LM Start		Rating **	A	Issue No.	4
LM End		Issue Type +	Ma	Location *	N/A
Category	Earthen Levee			GPS Latitude/Longitude	
				Start	End
Item	Emergency Supplies & Equipment				o
					o
DWR ID	DWR_RD2101_01_s_2013_4				
Comment Code					
Inspector Comment					
LMA has emergency supplies on site at the warehouse.

View of the emergency flood fight supplies in the shop.

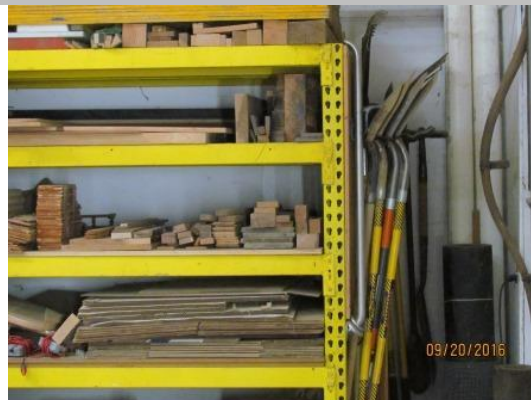
Photo 2 of 2 : SP_2019_RD2101_326_4_20190313_00003.jpg

Another view of the emergency flood fight supplies in the shop.

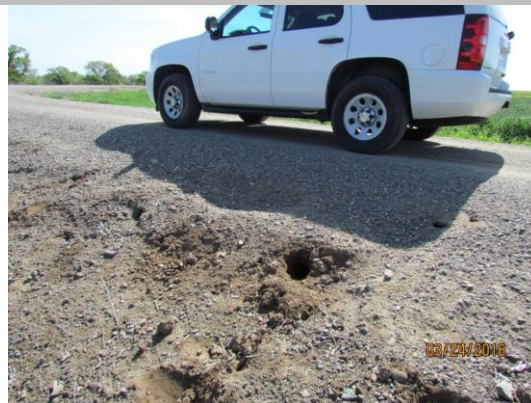
Photo 1 of 1 : SP_2019_RD2101_326_12_20190313_00005.jpg

View of the rodent holes on the waterside levee slope, facing upstream.

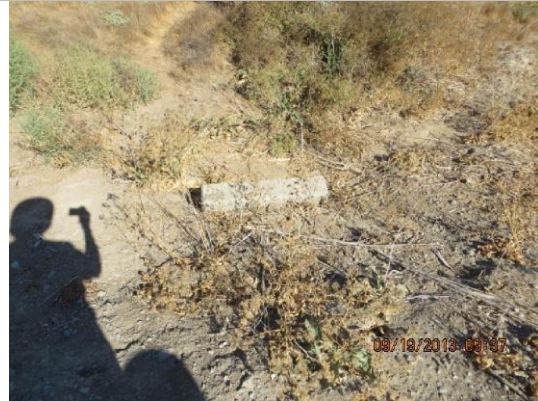
Photo 1 of 3 : UCIP_SP_2019_53384_47962.jpg

Comment Code					
Inspector Comment					
FS_ID:53384 DS_ID:20699 EP_NO: N/A Repair Type: Non-Urgent Crossing Status: Found UCIP Comments: 10/10/2018 The levee does not show any signs of integrity issues and the headwalls are in tact, even though the pipe has heavy sediment buildup. Downgrading to Non-Urgent and recommend cleaning out the pipe to allow drainage to pass through unobstructed (D. Sanoski - DWR UCIP). 11/16/2016 Same as previous inspection slide gate still missing. Also dense vegetation prevents access to crossing. Recommend removing vegetation along pipe alignment and both concrete headwalls to conduct proper inspection of structure. (O. Magana - DWR UCIP)09/17/2013 Slide gate missing from WS toe. Pipe has heavy sediment buildup. (W. Wylie - DWR UCIP) FIELD_STRUCT_DESC: 18-inch corrugated metal drainage pipe through the levee, 3 feet below the crown. Concrete headwalls on both ends. Slide gate at the headwall on the waterside (WS) end. [Additional Reference(s): DWR Levee Log, 1992. USACE San Joaquin O&M Manual 12, December 1968, (HLM 0.05), Drawing No. 07-04-1666, Sheets 1666/18 and 1666/52, (Station 00+70)]. FS Date: 10/10/2018 1:39:00 PM

Headwall on WS toe.

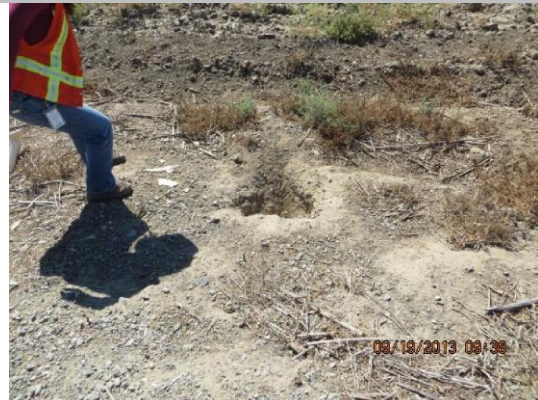
Photo 2 of 3 : UCIP_SP_2019_53384_47961.jpg

Pipe and headwall visible on LS toe.

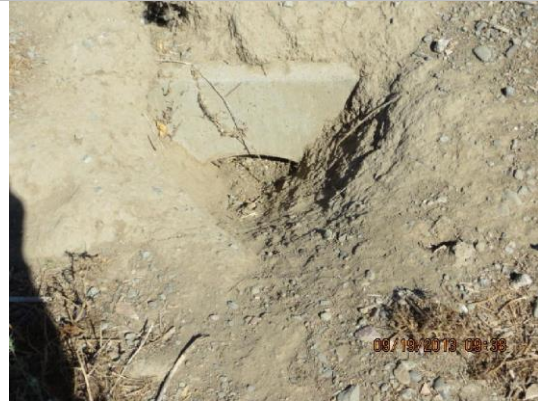
Photo 3 of 3 : UCIP_SP_2019_53384_47960.jpg

Comment Code						
Inspector Comment						
FS_ID:53384 DS_ID:20699 EP_NO: N/A Repair Type: Non-Urgent Crossing Status: Found UCIP Comments: 10/10/2018 The levee does not show any signs of integrity issues and the headwalls are in tact, even though the pipe has heavy sediment buildup. Downgrading to Non-Urgent and recommend cleaning out the pipe to allow drainage to pass through unobstructed (D. Sanoski - DWR UCIP). 11/16/2016 Same as previous inspection slide gate still missing. Also dense vegetation prevents access to crossing. Recommend removing vegetation along pipe alignment and both concrete headwalls to conduct proper inspection of structure. (O. Magana - DWR UCIP)09/17/2013 Slide gate missing from WS toe. Pipe has heavy sediment buildup. (W. Wylie - DWR UCIP) FIELD_STRUCT_DESC: 18-inch corrugated metal drainage pipe through the levee, 3 feet below the crown. Concrete headwalls on both ends. Slide gate at the headwall on the waterside (WS) end. [Additional Reference(s): DWR Levee Log, 1992. USACE San Joaquin O&M Manual 12, December 1968, (HLM 0.05), Drawing No. 07-04-1666, Sheets 1666/18 and 1666/52, (Station 00+70)]. FS Date: 10/10/2018 1:39:00 PM

Pipe and headwall visible on LS toe.

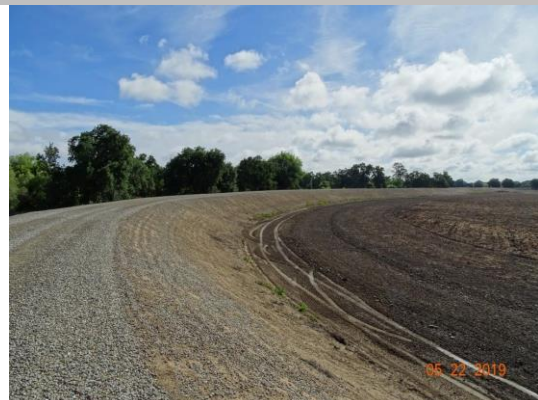
Photo 1 of 1 : SP_2019_RD2101_326_39_20190522_00054.jpg

LM Start	0.08	Rating **	A	Issue No.	39
LM End	2.74	Issue Type +	Ma	Location *	LS
Category	Earthen Levee			GPS Latitude/Longitude	
				Start	End
Item	Vegetation			37.657823 °	37.641545 °
				-121.253292 °	-121.229744 °
DWR ID	DWR_RD2101_01_s_2019_39				
Comment Code					
V1 : Control annual grass and weeds on the levee slopes and easements.					
Inspector Comment					
Annual vegetation on landside slope is well maintained.

Typical view of vegetation on landside slope. (Spring 2019)

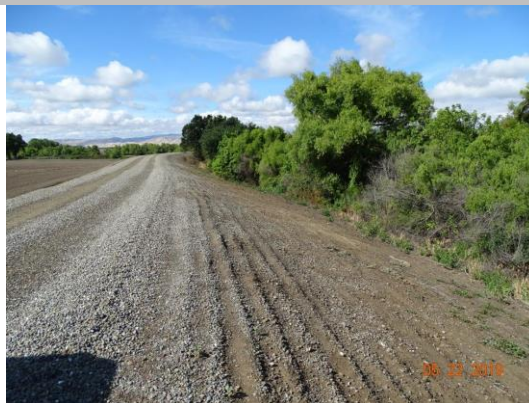
Photo 1 of 1 : SP_2019_RD2101_326_29_20190522_00055.jpg

Typical view of vegetation on waterside slope. (Spring 2019)

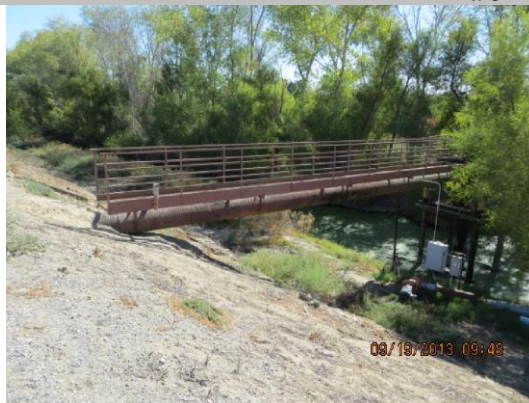
Photo 1 of 3 : UCIP_SP_2019_20752_34980.jpg

LM Start	0.20	Rating **	A/W	Issue No.	946	
LM End	0.20	Issue Type +	Ma	Location *		
Category	Supplemental			GPS Latitude/Longitude		
				Start	End	
Item	DWR UCIP LMA Responsibility			37.657130 °	37.657130 °	
				-121.251695 °	-121.251695 °	
DWR ID	20700					
Comment Code						
Inspector Comment						
FS_ID:20752						
DS_ID:20700						
EP_NO: N/A						
Repair Type: No Action Needed						
Crossing Status: Found						
UCIP Comments:						
FIELD_STRUCT_DESC: 20-inch steel drainage pipe through the levee, 2 feet below the crown. Concrete U-shaped headwall and flap gate on the waterside (WS) end. Pump on pile structure on the landside (LS). [Additional Reference(s): DWR Levee Log, 1992. USACE San Joaquin O&M Manual 12, December 1968, (HLM 0.20), 18-inch pipe listed].						
FS Date: 9/19/2013

Pump on platform at LS.

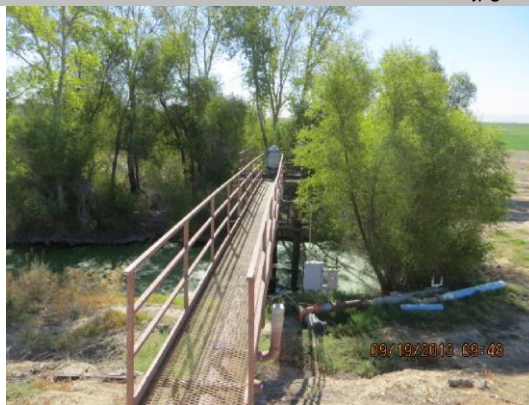
Photo 2 of 3 : UCIP_SP_2019_20752_34979.jpg

Pump on platform at LS.

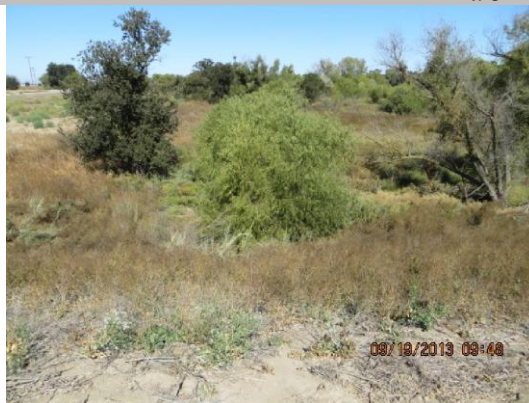
Photo 3 of 3 : UCIP_SP_2019_20752_34978.jpg

LM Start	0.20	Rating **	A/W	Issue No.	946 (cont)	
LM End	0.20	Issue Type +	Ma	Location *		
Category	Supplemental			GPS Latitude/Longitude		
				Start	End	
Item	DWR UCIP LMA Responsibility			37.657130 °	37.657130 °	
				-121.251695 °	-121.251695 °	
DWR ID	20700					
Comment Code						
Inspector Comment						
FS_ID:20752						
DS_ID:20700						
EP_NO: N/A						
Repair Type: No Action Needed						
Crossing Status: Found						
UCIP Comments:						
FIELD_STRUCT_DESC: 20-inch steel drainage pipe through the levee, 2 feet below the crown. Concrete U-shaped headwall and flap gate on the waterside (WS) end. Pump on pile structure on the landside (LS). [Additional Reference(s): DWR Levee Log, 1992. USACE San Joaquin O&M Manual 12, December 1968, (HLM 0.20), 18-inch pipe listed].						
FS Date: 9/19/2013

Concrete U-shaped headwall on LS toe at willow tree on WS toe.

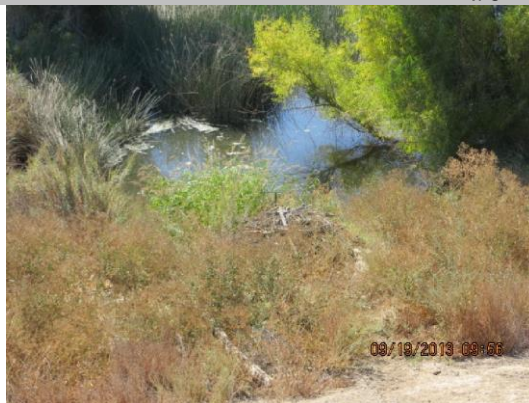
Photo 1 of 3 : UCIP_SP_2019_20785_35046.jpg

LM Start	0.31	Rating **	M	Issue No.	947
LM End	0.31	Issue Type +	Ma	Location *	
Category	Supplemental			GPS Latitude/Longitude	
				Start	End
Item	DWR UCIP LMA Responsibility			37.658142 °	37.658142 °
				-121.250047 °	-121.250047 °
DWR ID	20701				
Comment Code					
Inspector Comment					
FS_ID:20785 DS_ID:20701 EP_NO: N/A Repair Type: Non-Urgent Crossing Status: Found UCIP Comments: Inlet blocked by soil from beaver activity. Outlet covered in soil. FIELD_STRUCT_DESC: 24-inch corrugated metal drainage pipe through the levee, 21 feet below the crown. Headwall and slide gate on the landside (LS) end. Concrete U-shaped headwall and flap gate on the waterside (WS) end. [Additional Reference(s): DWR Levee Log, 1992. USACE San Joaquin O&M Manual 12, December 1968, (HLM 0.31)]. FS Date: 9/19/2013

Slide gate at concrete headwall on LS toe.

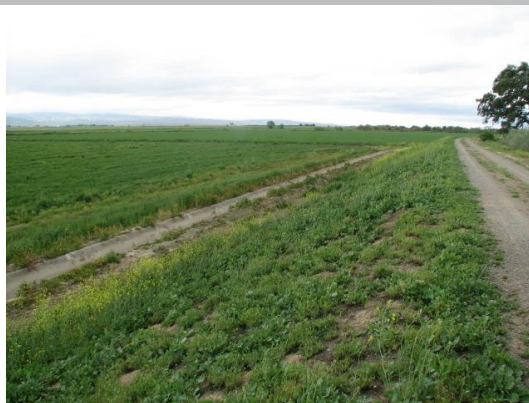
Photo 1 of 1 : SP_2019_RD2101_326_944_20190313_00024.jpg

Concrete ditch near landside toe.

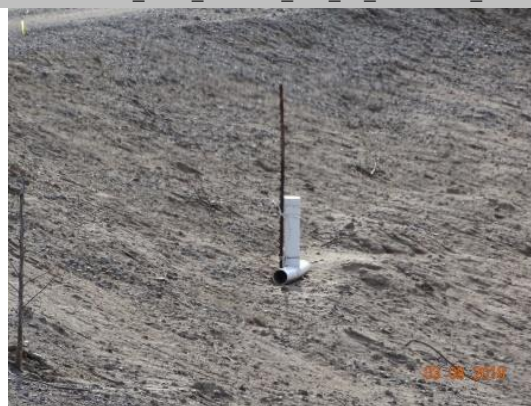
Photo 1 of 1 : SP_2019_RD2101_326_19_20190313_00010.jpg

View of the bait station on the levee slope.

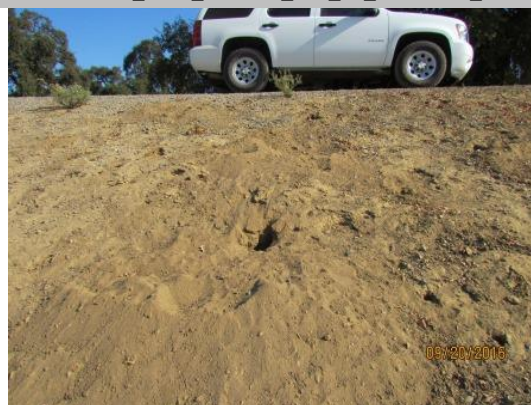
Photo 1 of 1 : SP_2019_RD2101_326_21_20190313_00011.jpg

LM Start	0.86	Rating **	M	Issue No.	21
LM End	0.86	Issue Type +	Ma	Location *	LS
Category	Earthen Levee			GPS Latitude/Longitude	
				Start	End
Item	Animal Control			37.658715 °	37.658715 °
				-121.241945 °	-121.241945 °
DWR ID	DWR_RD2101_01_f_2016_21				
Comment Code					
A3 : No rodents visible, but rodent burrows visible; need to backfill and compact or grout burrows.					
Inspector Comment

View of the rodent hole on the landside slope.

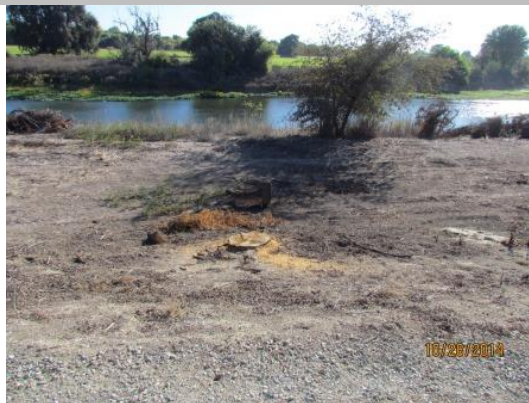
Photo 1 of 1 : SP_2019_RD2101_326_33_20190313_00019.jpg

View of the tree stump at the waterside levee toe.

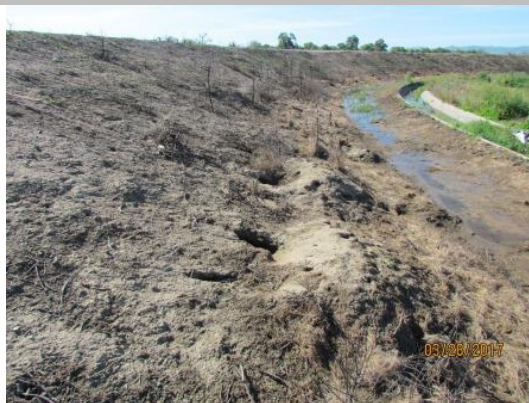
Photo 1 of 1 : SP_2019_RD2101_326_25_20190313_00014.jpg

View of the multiple rodent burrows on the levee slope.

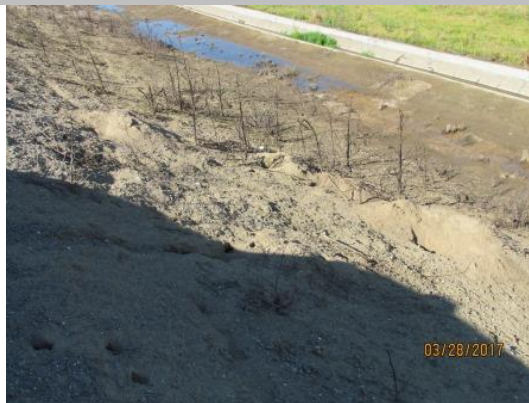
Photo 1 of 1 : SP_2019_RD2101_326_36_20190313_00020.jpg

LM Start	2.52	Rating **	C	Issue No.	30
LM End	2.52	Issue Type +	Ma	Location *	LS
Category	Earthen Levee			GPS Latitude/Longitude	
				Start	End
Item	Animal Control			37.644166 °	37.644166 °
				-121.228386 °	-121.228386 °
DWR ID	DWR_RD2101_01_s_2017_30				
Comment Code					
A3 : No rodents visible, but rodent burrows visible; need to backfill and compact or grout burrows.					
Inspector Comment					
Multiple large rodent holes have been filled.

View of the multiple rodent burrows on the levee slope.

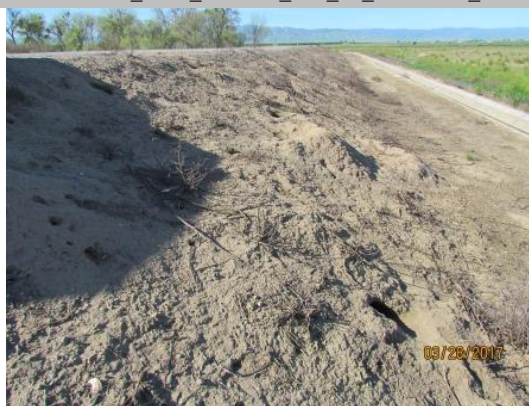
Photo 1 of 1 : SP_2019_RD2101_326_37_20190313_00021.jpg

View of the multiple rodent burrows on the levee slope.

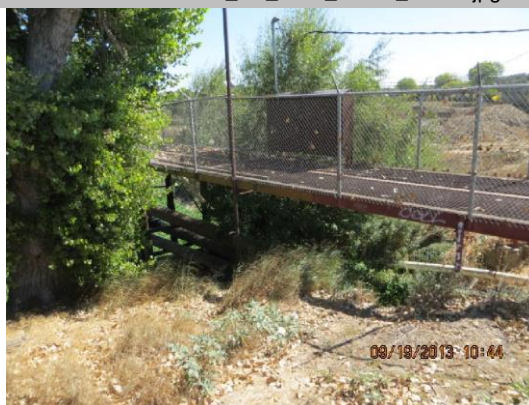
Photo 1 of 3 : UCIP_SP_2019_20865_35110.jpg

LM Start	2.71	Rating **	M	Issue No.	948	
LM End	2.71	Issue Type +	En	Location *		
Category	Supplemental			GPS Latitude/Longitude		
				Start		End
Item	DWR UCIP Field Study			37.641976 °		37.641976 °
				-121.229745 °		-121.229745 °
DWR ID	20711					
Comment Code						
Inspector Comment						
FS_ID:20865 DS_ID:20711 EP_NO: N/A Repair Type: Non-Urgent Crossing Status: Found UCIP Comments: Pipe leaking at pipe/concrete connection on WS slope. FIELD_STRUCT_DESC: 2 of 3: 20-inch concrete encased steel irrigation pipe through the levee, 10 feet below the crown. Pump on steel pier on the waterside (WS). Gate valve in a 16-foot by 7-foot concrete vault on the WS shoulder. Pipes discharge into a concrete canal on the landside (LS) toe. [Additional Reference(s): DWR Levee Log, 1992. USACE San Joaquin O&M Manual 12, December 1968, (HLM 2.73)]. FS Date: 9/19/2013

Pump on metal pier on WS.

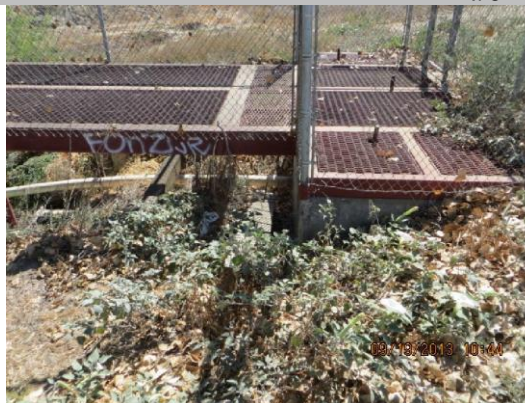
Photo 2 of 3 : UCIP_SP_2019_20865_35109.jpg

LM Start	2.71	Rating **	M	Issue No.	948 (cont)	
LM End	2.71	Issue Type +	En	Location *		
Category	Supplemental			GPS Latitude/Longitude		
				Start		End
Item	DWR UCIP Field Study			37.641976 °		37.641976 °
				-121.229745 °		-121.229745 °
DWR ID	20711					
Comment Code						
Inspector Comment						
FS_ID:20865 DS_ID:20711 EP_NO: N/A Repair Type: Non-Urgent Crossing Status: Found UCIP Comments: Pipe leaking at pipe/concrete connection on WS slope. FIELD_STRUCT_DESC: 2 of 3: 20-inch concrete encased steel irrigation pipe through the levee, 10 feet below the crown. Pump on steel pier on the waterside (WS). Gate valve in a 16-foot by 7-foot concrete vault on the WS shoulder. Pipes discharge into a concrete canal on the landside (LS) toe. [Additional Reference(s): DWR Levee Log, 1992. USACE San Joaquin O&M Manual 12, December 1968, (HLM 2.73)]. FS Date: 9/19/2013

Gate valve in concrete vault on WS shoulder.

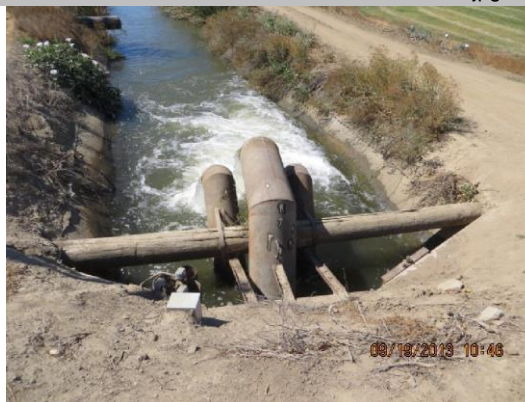
Photo 3 of 3 : UCIP_SP_2019_20865_35108.jpg

20-inch steel pipe discharges into concrete channel on LS.

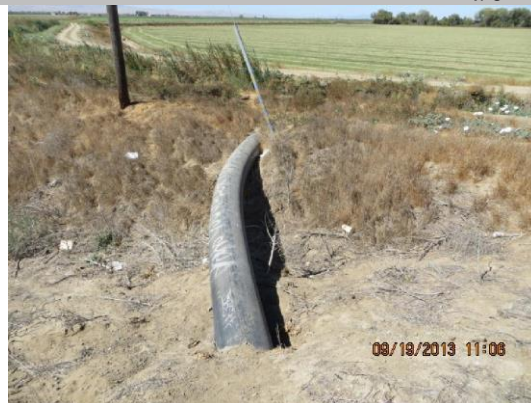
Photo 1 of 2 : UCIP_SP_2019_22915_39043.jpg

LM Start	2.72	Rating **	M	Issue No.	949
LM End	2.72	Issue Type +	En	Location *	
Category	Supplemental			GPS Latitude/Longitude	
				Start	End
Item	DWR UCIP Field Study			37.641798 °	37.641798 °
				-121.229714 °	-121.229714 °
DWR ID	24679				
Comment Code					
Inspector Comment					
FS_ID:22915 DS_ID:24679 EP_NO: N/A Repair Type: Non-Urgent Crossing Status: Found UCIP Comments: 09/26/2016 - (T. Hatch/UCIP) Inspector indicated that pipe had been removed for several years. Need additional information to determine if the pipe was removed properly and the levee recompacted to specifications. 09/19/2013 - (W. Wylie/UCIP) No permit identified for this crossing. FIELD_STRUCT_DESC: *REMOVED* 18-inch polyvinyl chloride (PVC) irrigation pipe through the levee, 3.5 feet below the crown. No pump or other appurtenances visible. FS Date: 9/19/2013

18-inch PVC pipe visible at LS slope.

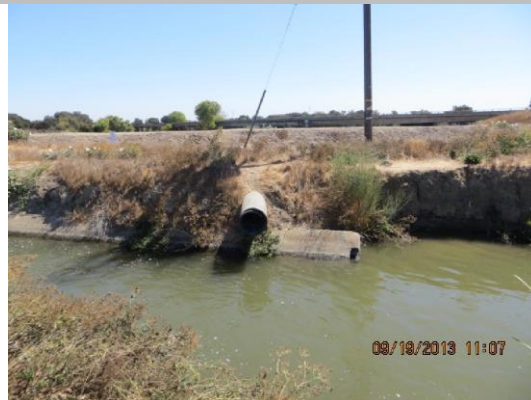
Photo 2 of 2 : UCIP_SP_2019_22915_39042.jpg

18-inch PVC pipe visible at outlet to irrigation canal on LS slope.

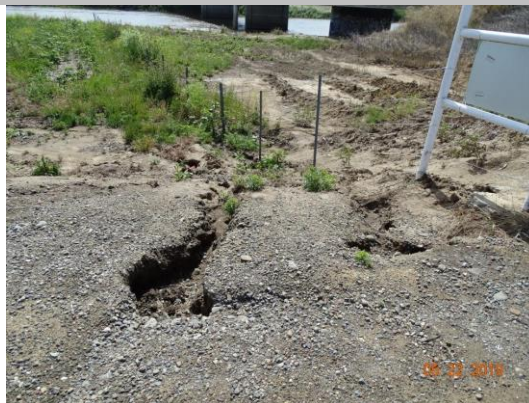
Photo 1 of 1 : SP_2019_RD2101_326_49_20190522_00056.jpg

LM Start	2.74	Rating **	U	Issue No.	49
LM End	2.74	Issue Type +	Ma	Location *	WS
Category	Earthen Levee			GPS Latitude/Longitude	
				Start	End
Item	Erosion / Bank Caving			37.641545 °	37.641545 °
				-121.229744 °	-121.229744 °
DWR ID	DWR_RD2101_01_s_2019_49				
Comment Code					
E2 : Schedule repair of erosion site prior to the next inspection.					
Inspector Comment					
There is erosion on the waterside shoulder extending down the slope. Most likely caused by surface runoff from adjacent highway. Scheduled for repair.

Waterside shoulder erosion most likely caused by surface runoff from adjacent highway. RD has scheduled repair. (Spring 2019)

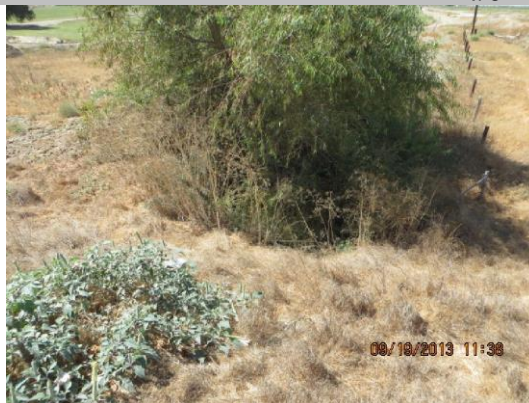
Photo 1 of 3 : UCIP_SP_2019_53201_35142.jpg

FS_ID:53201
DS_ID:20705
EP_NO: N/A
Repair Type: Non-Urgent
Crossing Status: Found
UCIP Comments: 10/10/2018 Although there was heavy vegetation, there were no visible levee or pipe threats; downgrading to Non-Urgent (D. Sanoski - DWR UCIP).11/16/2016 No access available. Need to coordinate with LMA to obtain access for proper inspection at a later date. (O. Magana - DWR UCIP)09/19/2013 Flap gate missing from WS headwall. (W. Wylie - DWR UCIP)
FIELD_STRUCT_DESC: 24-inch corrugated metal drainage pipe through the levee, 11 feet below the crown. Concrete U-shaped headwalls on both ends. Flap gate on the waterside (WS) end.
[Additional Reference(s): DWR Levee Log, 1992. USACE San Joaquin O&M Manual 12, December 1968, (HLM 2.85), Drawing No. 07-04-1666, Sheets 1666/13 and 1666/51, (Station 421+30)].
FS Date: 10/10/2018 2:24:25 PM

Concrete headwall visible at LS toe in ditch.

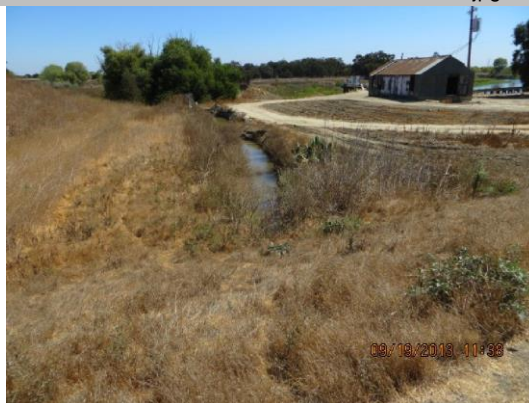
Photo 2 of 3 : UCIP_SP_2019_53201_35141.jpg

Concrete headwall visible on WS toe at canal.

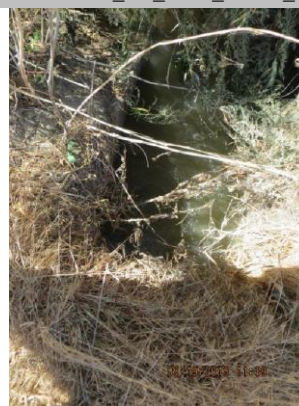
Photo 3 of 3 : UCIP_SP_2019_53201_35140.jpg

Comment Code						
Inspector Comment						
FS_ID:53201 DS_ID:20705 EP_NO: N/A Repair Type: Non-Urgent Crossing Status: Found UCIP Comments: 10/10/2018 Although there was heavy vegetation, there were no visible levee or pipe threats; downgrading to Non-Urgent (D. Sanoski - DWR UCIP).11/16/2016 No access available. Need to coordinate with LMA to obtain access for proper inspection at a later date. (O. Magana - DWR UCIP)09/19/2013 Flap gate missing from WS headwall. (W. Wylie - DWR UCIP) FIELD_STRUCT_DESC: 24-inch corrugated metal drainage pipe through the levee, 11 feet below the crown. Concrete U-shaped headwalls on both ends. Flap gate on the waterside (WS) end. [Additional Reference(s): DWR Levee Log, 1992. USACE San Joaquin O&M Manual 12, December 1968, (HLM 2.85), Drawing No. 07-04-1666, Sheets 1666/13 and 1666/51, (Station 421+30)]. FS Date: 10/10/2018 2:24:25 PM

Concrete headwall at LS toe.

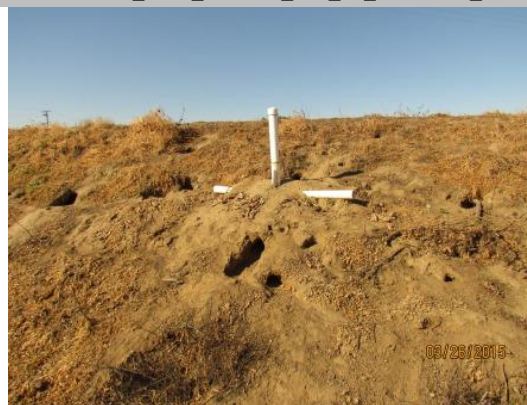
Photo 1 of 1 : SP_2019_RD2101_326_27_20190313_00016.jpg

LM Start	2.83	Rating **	U	Issue No.	27
LM End	2.83	Issue Type +	Ma	Location *	WS
Category	Earthen Levee			GPS Latitude/Longitude	
				Start	End
Item	Animal Control			37.640425 °	37.640425 °
				-121.230139 °	-121.230139 °
DWR ID	DWR_RD2101_01_s_2012_27				
Comment Code					
A3 : No rodents visible, but rodent burrows visible; need to backfill and compact or grout burrows.					
Inspector Comment					
There are burrows on both sides of the levee. Backfill the burrows to restore the levee to original condition.

View of multiple rodent holes on the levee slope.

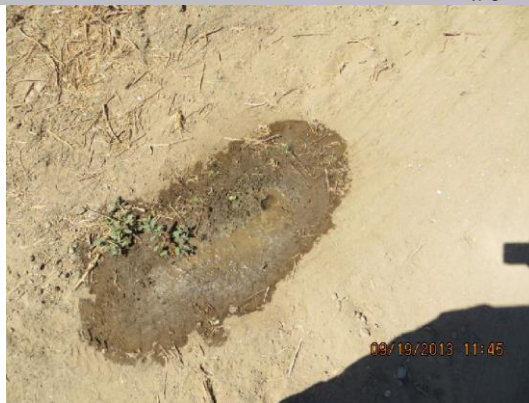
Photo 1 of 3 : UCIP_SP_2019_20873_35146.jpg

Comment Code						
Inspector Comment						
FS_ID:20873 DS_ID:20706 EP_NO: N/A Repair Type: Non-Urgent Crossing Status: Found UCIP Comments: Leaks off LS toe may indicate internal failure. Good candidate for video inspection. FIELD_STRUCT_DESC: 1 of 2: 24-inch reinforced concrete irrigation pipe through the levee, 11 feet below the crown. Pump on metal pier at the berm. Screw gates in a 6-foot by 10.5-foot concrete box on the waterside (WS). 12-inch steel riser next to concrete box with slide gates. Abandoned pump house on the WS. [Additional Reference(s): DWR Levee Log, 1992. USACE San Joaquin O&M Manual 12, December 1968, (HLM 2.87)]. FS Date: 9/19/2013

Leak in pipe off LS toe.

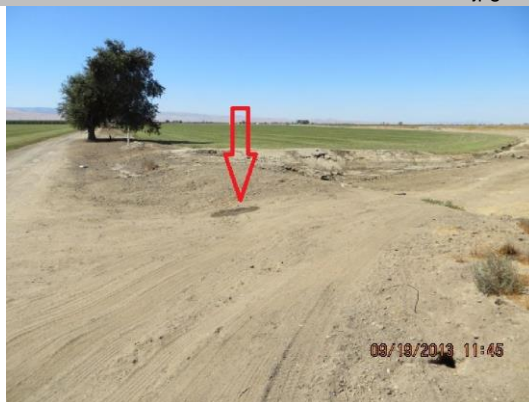
Photo 2 of 3 : UCIP_SP_2019_20873_35145.jpg

Leak in pipe off LS toe.

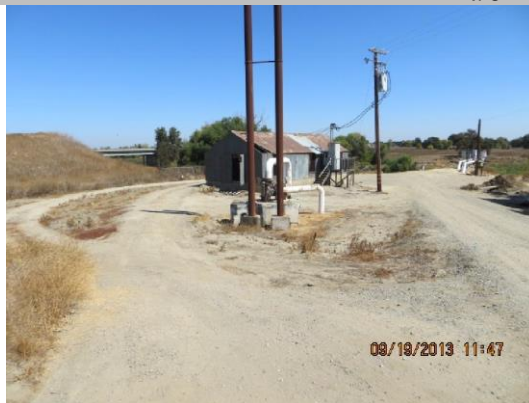
Photo 3 of 3 : UCIP_SP_2019_20873_35144.jpg

Comment Code						
Inspector Comment						
FS_ID:20873 DS_ID:20706 EP_NO: N/A Repair Type: Non-Urgent Crossing Status: Found UCIP Comments: Leaks off LS toe may indicate internal failure. Good candidate for video inspection. FIELD_STRUCT_DESC: 1 of 2: 24-inch reinforced concrete irrigation pipe through the levee, 11 feet below the crown. Pump on metal pier at the berm. Screw gates in a 6-foot by 10.5-foot concrete box on the waterside (WS). 12-inch steel riser next to concrete box with slide gates. Abandoned pump house on the WS. [Additional Reference(s): DWR Levee Log, 1992. USACE San Joaquin O&M Manual 12, December 1968, (HLM 2.87)]. FS Date: 9/19/2013

12-inch steel riser at concrete box with gatevalve on WS berm.

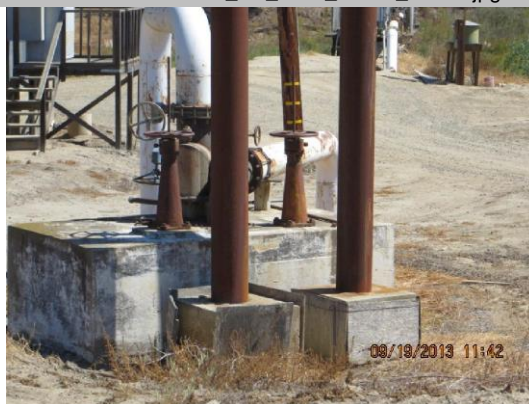
Photo 1 of 3 : UCIP_SP_2019_20874_35151.jpg

LM Start	2.85	Rating **	M	Issue No.	952
LM End	2.85	Issue Type +	En	Location *	
Category	Supplemental			GPS Latitude/Longitude	
				Start	End
Item	DWR UCIP Field Study			37.640185 °	37.640185 °
				-121.230067 °	-121.230067 °
DWR ID	20712				
Comment Code					
Inspector Comment					
FS_ID:20874 DS_ID:20712 EP_NO: N/A Repair Type: Non-Urgent Crossing Status: Found UCIP Comments: Leak off LS toe may indicate internal failure. Good candidate for video inspection. FIELD_STRUCT_DESC: 2 of 2: 30-inch reinforced concrete irrigation pipe through the levee, 11 feet below the crown. Pump on metal pier on the berm. 12-inch steel riser next to a 6-foot by 10.5-foot concrete box with a screw gate inside on the waterside (WS). Abandoned pump house on the WS. [Additional Reference(s): DWR Levee Log, 1992. USACE San Joaquin O&M Manual 12, December 1968, (HLM 2.87)]. FS Date: 9/19/2013

Gatevalve in concrete vault with standpipe off WS toe.

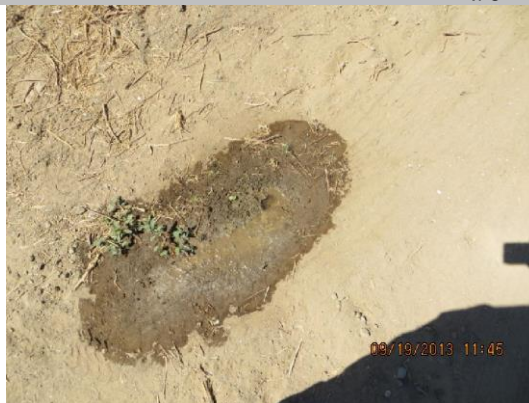
Photo 2 of 3 : UCIP_SP_2019_20874_35150.jpg

Comment Code						
Inspector Comment						
FS_ID:20874 DS_ID:20712 EP_NO: N/A Repair Type: Non-Urgent Crossing Status: Found UCIP Comments: Leak off LS toe may indicate internal failure. Good candidate for video inspection. FIELD_STRUCT_DESC: 2 of 2: 30-inch reinforced concrete irrigation pipe through the levee, 11 feet below the crown. Pump on metal pier on the berm. 12-inch steel riser next to a 6-foot by 10.5-foot concrete box with a screw gate inside on the waterside (WS). Abandoned pump house on the WS. [Additional Reference(s): DWR Levee Log, 1992. USACE San Joaquin O&M Manual 12, December 1968, (HLM 2.87)]. FS Date: 9/19/2013

Leak in pipe off LS toe.

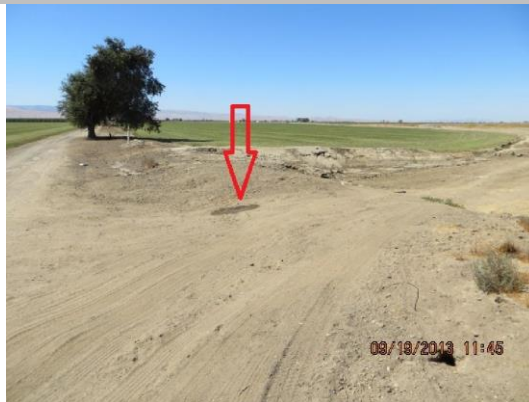
Photo 3 of 3 : UCIP_SP_2019_20874_35149.jpg

Leak in pipe off LS toe.

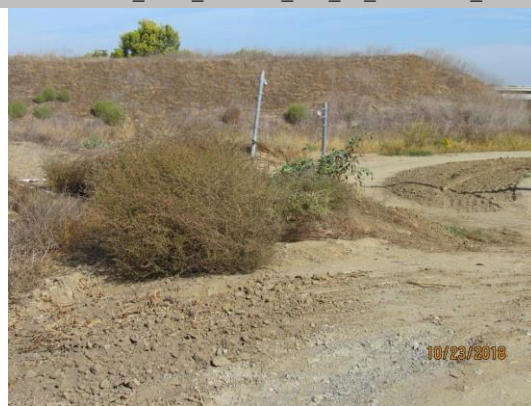
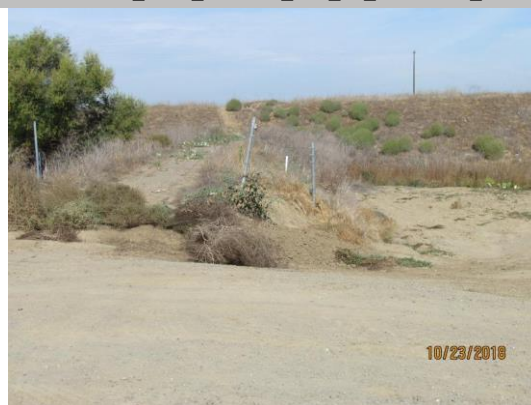
Photo 2 of 2 : SP_2019_RD2101_326_44_20190313_00023.jpg

LM Start	2.85	Rating **	U	Issue No.	44 (cont)
LM End	2.85	Issue Type +	En	Location *	CR

Damage on WS slope and crown.

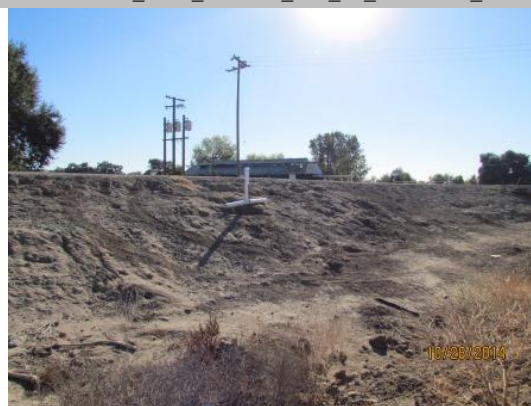
Photo 1 of 1 : SP_2019_RD2101_326_28_20190313_00017.jpg

View of numerous rodent holes with bait stations present.

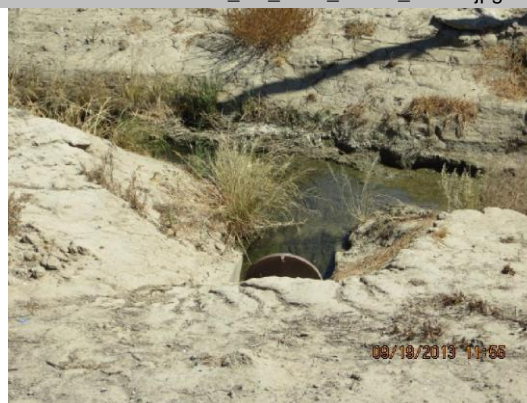
Photo 1 of 3 : UCIP_SP_2019_20875_35156.jpg

Flapgate on WS toe at concrete headwall.

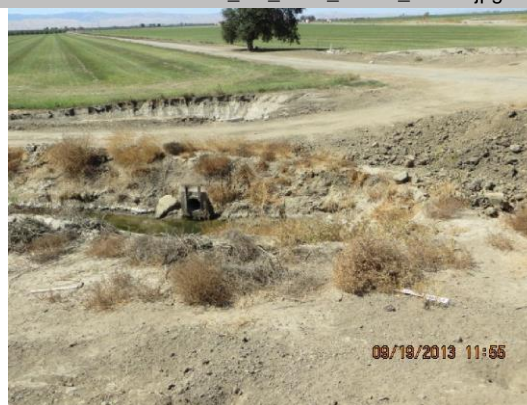
Photo 2 of 3 : UCIP_SP_2019_20875_35155.jpg

Inlet on LS toe with concrete headwall.

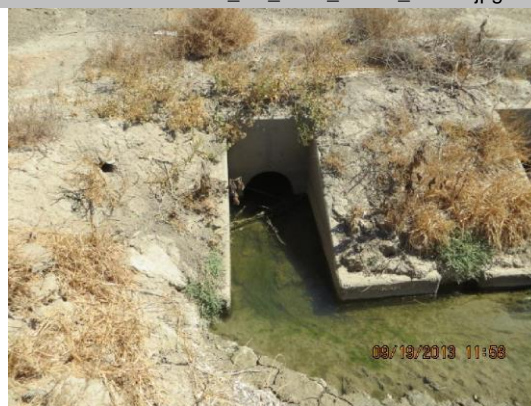
Photo 3 of 3 : UCIP_SP_2019_20875_35154.jpg

Inlet on LS toe with concrete headwall.

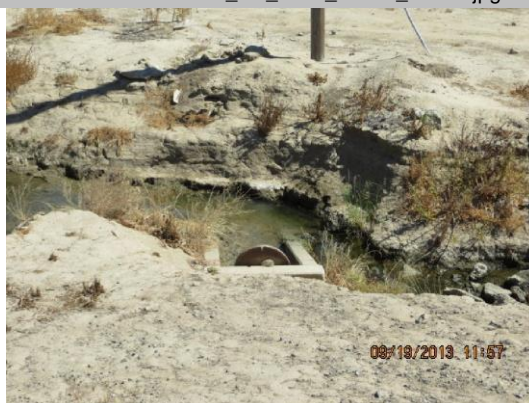
Photo 2 of 3 : UCIP_SP_2019_20876_35158.jpg

Concrete U-shaped headwall on WS toe with flapgate.

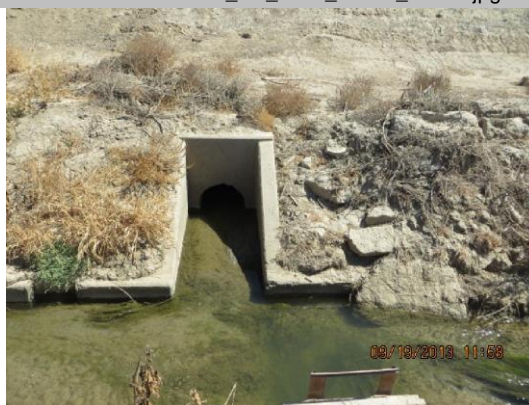
Photo 3 of 3 : UCIP_SP_2019_20876_35157.jpg

Concrete inlet on LS toe at canal.

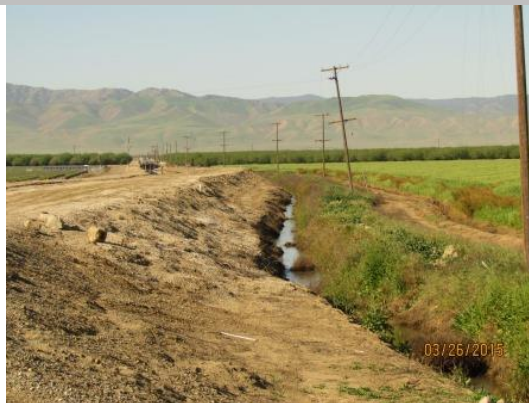
Photo 1 of 1 : SP_2019_RD2101_326_8_20190313_00004.jpg

View of the ditch at the landside levee toe.

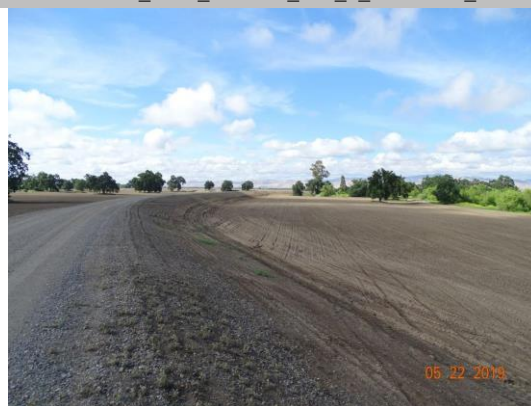
Photo 1 of 1 : SP_2019_RD2101_327_3_20190522_00002.jpg

Typical view of vegetation on landside slope. (Spring 2019)
